CASE STUDY

PHASE I & II ENVIRONMENTAL SITE ASSESSMENT

Industrial Facility
Northeastern Ohio

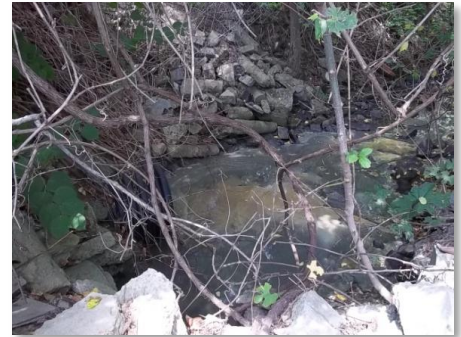
- Oil was observed in a drainage ditch at the facility storm sewer outfall.
- Oil was in constant contact with the concrete floor around machinery inside the facility.
- The facility historically operated as an aluminum product manufacturing facility and included an anodizing line. Chromic acid was often used in this process, and potential contamination of the groundwater supply with hexavalent chromium was a concern.

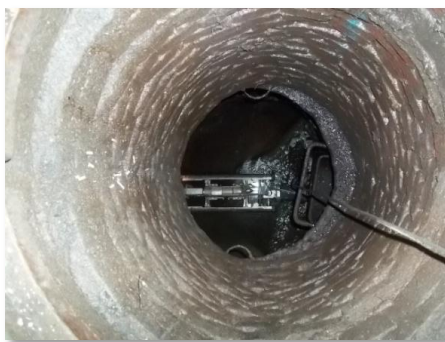
IGI implemented a Phase II ESA to investigate the source of oil in the storm sewer. Samples of the liquid in the storm sewer were collected and submitted for laboratory analysis to determine the nature of the liquid for disposal purposes. The liquid was determined to be non-hazardous and met the requirements for recycling. The storm sewer was then cleaned to remove the existing oil, and a camera study was performed to inspect the length of storm sewer beneath the facility. Through the camera study, it was determined that the entry point of oil into the storm sewer correlated with the location of accumulated oil on the concrete floor in the production area.

Ultimately, the cause of the environmental condition was a lapse in best management practices. The company owner implemented suitable practices that ensured no further oil accumulation on the exposed concrete floor.
