**INSITE GROUP, INC.**

# CASE STUDY

## POND SEDIMENT REMOVAL

Commercial / Industrial Facility  
Western Pennsylvania

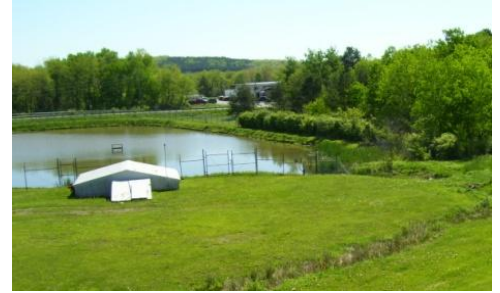
A pond contained several feet of sediment consisting of fine metallic particles coated with cutting oil. The source of the material was a historical metal cutting operation that used oil to cool the blade. Process oil and metal fines then entered the pond and accumulated on the bottom. The pond serves as a source of water to the fire system and could not be dewatered due to the conditions of the insurance policy. No local public water supply having sufficient volume and pressure was available to feed the fire system on an interim basis. The pond has a clay liner and single outfall to a high quality stream. The pond was classified as a Residual Waste Impoundment due to its historical permit status.

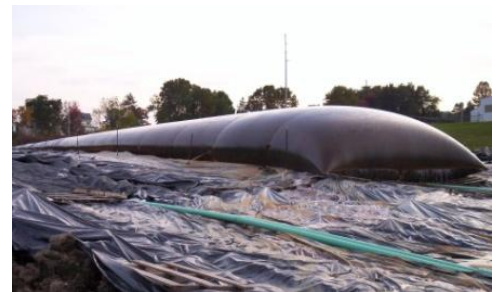
IGI used a remote-controlled floating dredge to evacuate and pump sediments from the pond bottom to two bag filters measuring 200 by 40 feet in area. An in-line pump was used to inject flocculant into the main feed line where mixing occurred. The sediments accumulated in the bags while the effluent discharged through the bag walls and into a drainage swale leading back into the pond. During this process the outfall was protected using booms to ensure the highest quality for the pond discharge.

Sediments were dried in the bags. Later, the bags were cut open and the sediments loaded for transport and disposal at a landfill in accordance with a Form U permit. Post-removal attainment sampling of pond sediments showed that 97% of the sediment had been removed. A Closure Report for the site was approved by the PADEP.
